Research Paper

Failure modes of Y-TZP abutments with external hex implant-abutment connection determined by fractographic analysis

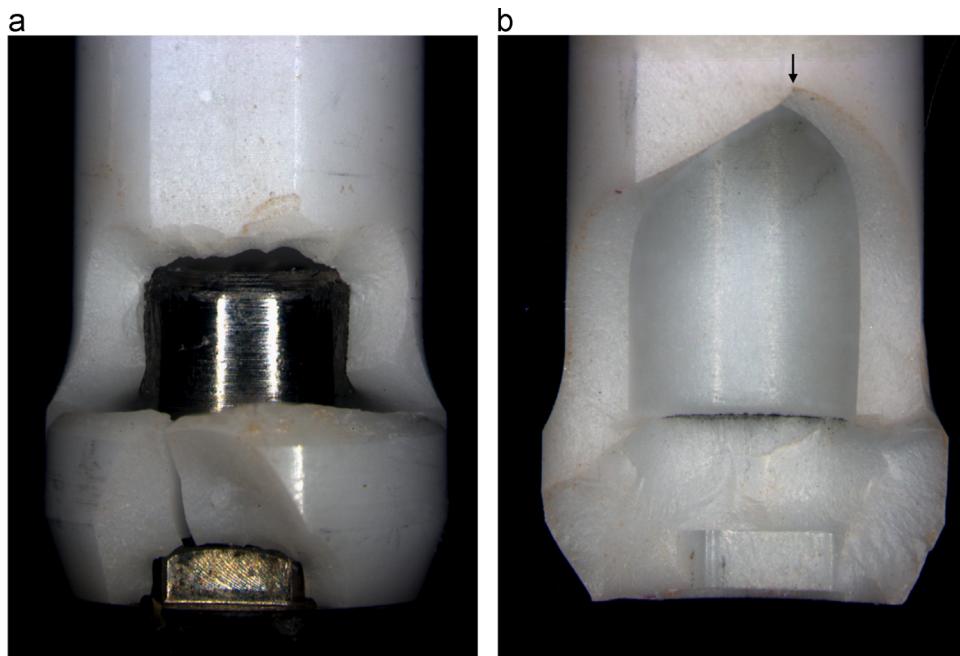
Fig. 1 – (a) Stereomicroscopic image of an abutment showing multiple fractures at the connecting region. **(b)** Stereomicroscopic image of an abutment showing the fracture near the loading area (small black arrow).

The initial stereo analysis revealed that two fracture patterns could be identified. The predominant scenario observed in all groups was abutment fracture at the connecting region originated from the abutment screw head and hexagon vertex (Fig. 1a). However, some specimens also showed abutment fracture near the loading area which suggested that the failure originated from the loading point and then propagated downwards (Fig. 1b).

study, multiple cracks were sometimes propagated simultaneously in Y-TZP abutment-like complex geometries (see Fig. 1a). However, a general pattern of crack extension at the connecting area suggested that fracture started from this region.

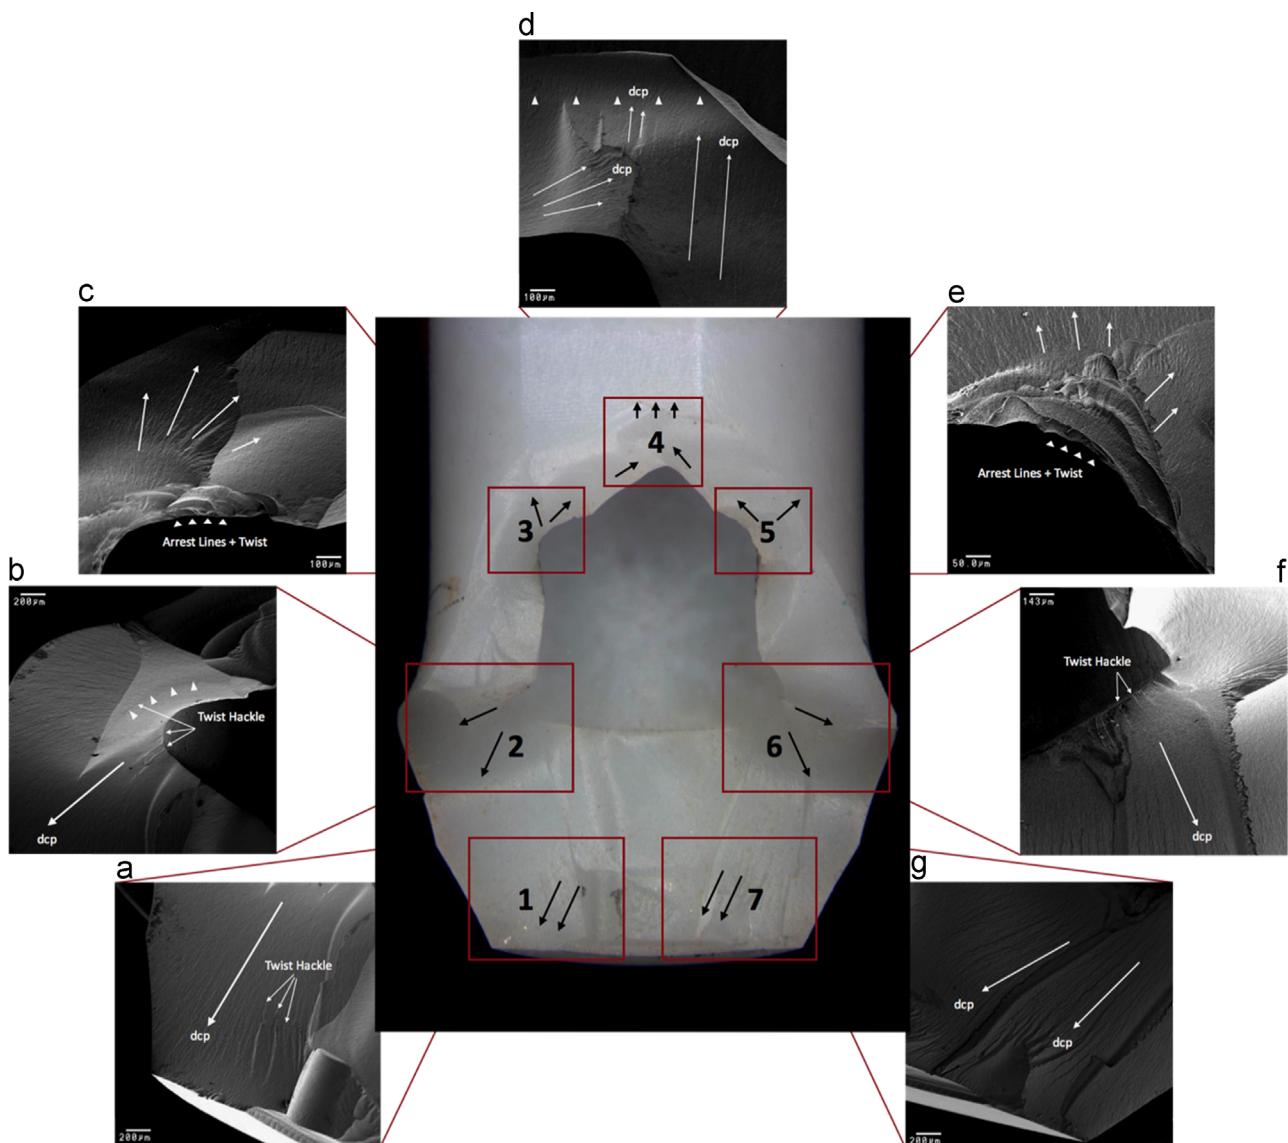
Fig. 2 – Representative abutment exposing part of the fracture surface examined under the SEM. Zones of interest are numbered 1–7 starting at the left margin to the other side of the abutment. Black arrows have been drawn indicating the general directions of crack propagation.

Fig. 2 shows a representative abutment of the fracture pattern near the loading area and the zones of interest for detailed fractographic analysis according to the systematic approach proposed by Scherrer et al. (2008). The analysis started at the left gingival margin of the fracture surface,

moving upwards towards the occlusal section and finishing at the right end side of the abutment (numbers 1–7 in Fig. 2). Based on the microscope findings, a final map was then created on the overall view of the representative abutment indicating the general directions of crack propagation.

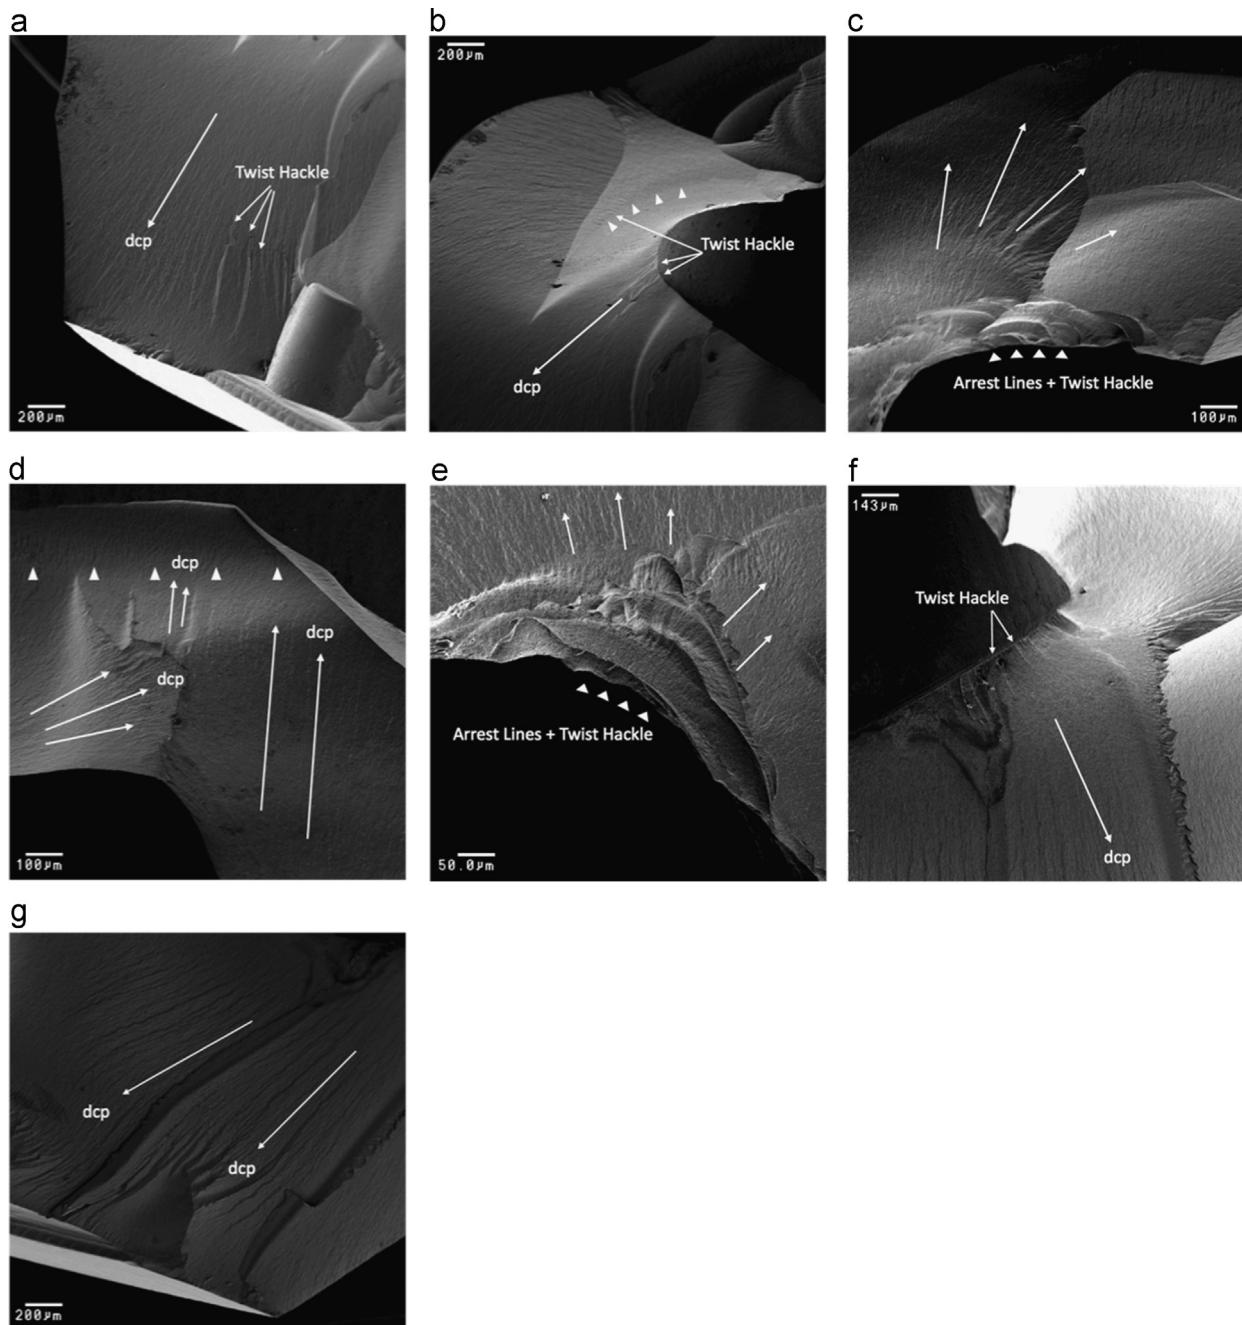
Fig. 3 – (a) SEM image of zone 1. Fractographic features like twist hackle are clearly visible on the fracture surface as indicated by the arrows. Indeed, many micro-fine texture hackle lines are propagating downwards to the gingival margin of the abutment. These features provide clear indication as to the direction of crack propagation (dcp) in this region (big white arrow). **(b)** SEM image of zone 2 showing twist hackle emanating from the abutment region that was in contact with the lower edge of the abutment screw head and these fine hackle together with a lateral arrest line (white arrowheads). These fractographic features confirmed that the fracture front moved from this region towards the gingival area and laterally. Other features are visible in Fig. 3b and serve as an evidence of dcp like micro-fine hackle lines. **(c)** SEM image of zone 3 showing multiple origins (damages) in the form of radial arrest lines. It is also possible to note the presence of twist hackle lines departing from the damage zone and connecting adjacent arrest lines (white arrowheads). Arrays of hackle moving laterally and upwards could also be identified (white arrows). **(d)** SEM image of zone 4 showing multiple micro-fine hackle propagating to the occlusal area as a result of the crack path moving from both proximal sides. Indeed, the existence of a compression curl, which is the curved lip just before the total fracture of a body loaded in bending, confirmed that the crack moved outwards exiting at the occlusal wall (white arrowheads in Fig. 4d). **(e)** SEM image of zone 5 showing fractographic features (radially arrest lines from which twist hackle emanated) like the homologous zone. **(f)** SEM image of zone 6 showing fractographic features (twist hackle and micro-fine hackle lines) like the homologous zone. **(g)** SEM image of zone 7 showing fractographic features (micro-fine hackle lines) like the homologous zone.

The initial SEM inspection of zone 1 (Fig. 3a) indicated that the crack was running downwards. The big white arrow labeled “dcp” shows the direction of the crack propagation. The SEM image of zone 2 (Fig. 3b), which corresponds to the abutment region that was in contact with the lower edge of the abutment screw head, indicated that the dcp moved from this region downwards and laterally. The inspection of zone 3 (Fig. 3c), which corresponds to the abutment region that was in contact with the upper edge of the abutment screw head, exhibited one area of multiple origins based on radially arrest lines from which twist huckle emanated. It was possible to observe the crack propagation from both proximal sides under the SEM analysis of zone 4 (Fig. 3d). The large arrows indicate the dcp. Furthermore, zones on the right side exhibited fractographic features like those of the homologous zones on the left side (Fig. 3e–g).

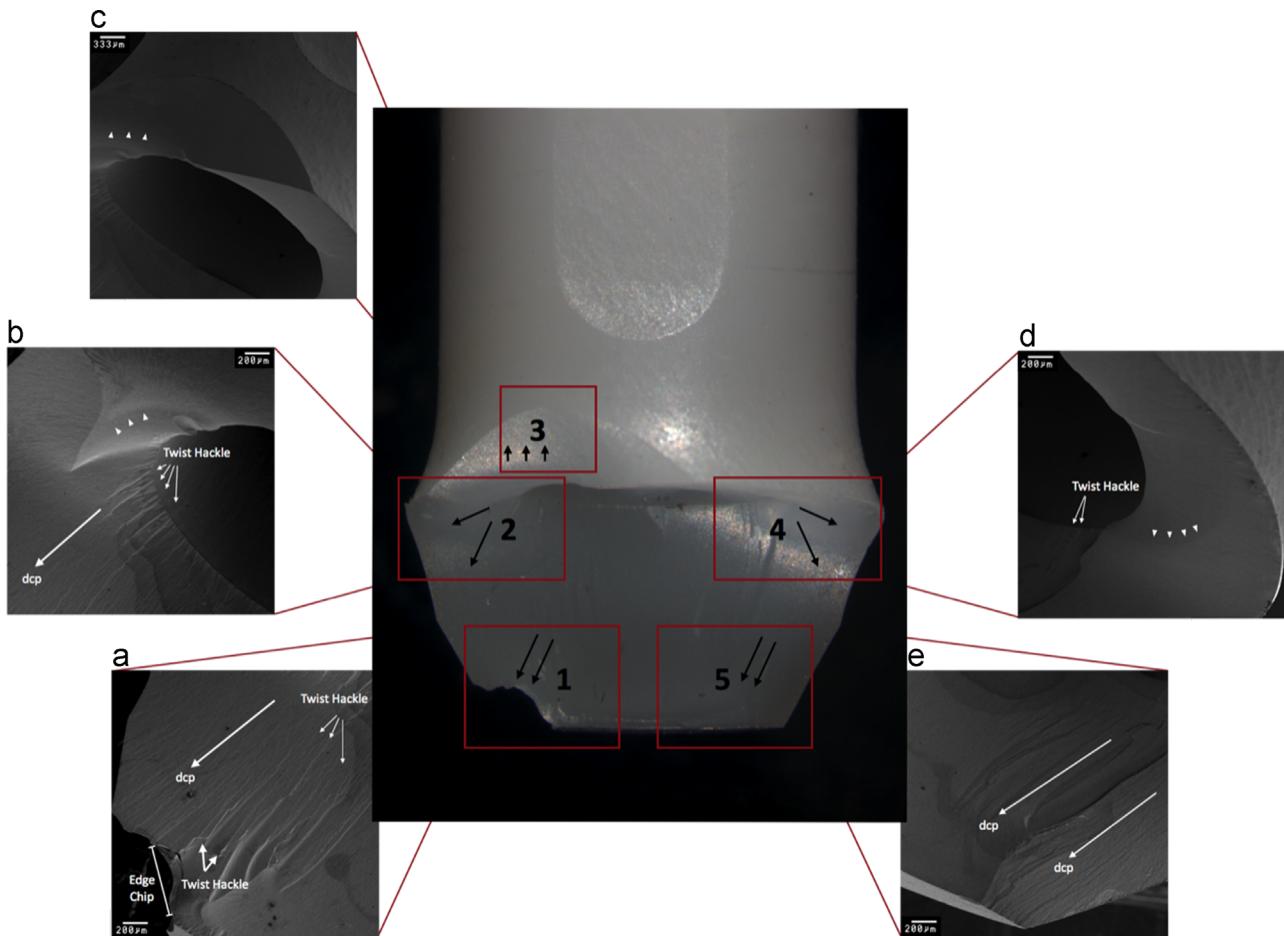
Fig. 4 – Representative abutment exposing part of the fracture surface examined under the SEM. Zones of interest are numbered 1–5 starting at the left margin to the other side of the abutment. Black arrows have been drawn indicating the general directions of crack propagation.

Fig. 4 shows a representative abutment of the fracture pattern related to the connecting region and the zones of interest for detailed fractographic analysis (Scherrer et al.,

It is also important to note that the screw head design has acute edges (see Figs. 4 and 5). This edge design is consistent with higher stress levels (Dundurs and Lee, 1972) and therefore unsuitable for Y-TZP abutments because of the characteristic brittleness of ceramic materials (Aboushelib and Salameh, 2009). In particular, it can be assumed that multiple implant-abutment connections in large Y-TZP infrastructures over implants may lead to more stress concentrations. The present findings indicated that the screw head and fitting surface of the abutment should have a rounded-edge design to ensure the integrity of Y-TZP implant restorations. Further studies using an *in vitro* set-up that achieve clinical fracture features as well as prospective long-term clinical studies should be conducted to elucidate the reasons why Y-TZP implant restorations fail. In addition, the damage of the external hex observed in some implants was also reported in previous studies as a result of the high hardness of Y-TZP abutments (Delben et al., 2014; Nguyen et al., 2009). Clinically, implant damage is a critical type of failure since it would probably require implant removal and repetition of the prosthetic work. Therefore, the mechanical behavior of such components should be better understood first to guarantee high reliability in the long term.

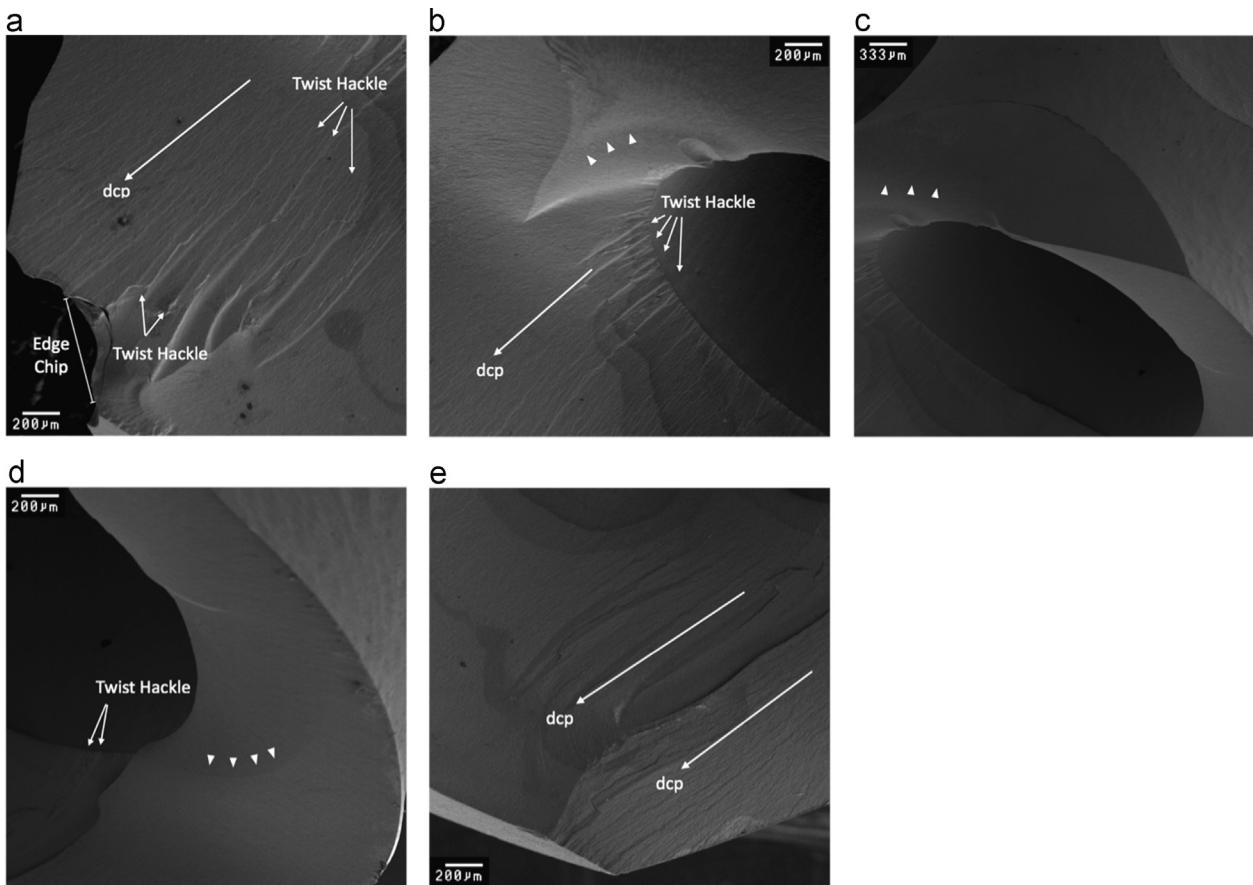
The SEM image of zone 1 (Fig. 5a) showed twist huckle and many micro-fine huckle lines propagating downwards as well as in the corresponding zone of the above-described abutment. The SEM image of zone 2 (Fig. 5b) revealed exactly the same landmarks as those observed in the corresponding zone of the above-described abutment. These fractographic features confirmed that the fracture front originated from this region and therefore, the abutment screw directly affected the occurrence of failure. Indeed, the inspection of zone 3 (Fig. 5c) showed a compression curl which confirmed that the crack moved outwards exiting at the occlusal wall. The zones on the right side exhibited fractographic features like those of the homologous zones on the left side (Fig. 5d and e).

Fig. 5 – (a) SEM image of zone 1. Fractographic features like twist hackle and micro-fine hackle lines indicate that the crack was running downwards to the gingival margin. The big white arrow shows the dcp. However, it is possible to observe twist hackle lines departing from the edge chip on the gingival margin in the opposite direction. This edge chip crack is probably a secondary event related to the hexagon vertex as seen by the presence of many hackle lines propagating downwards. The white arrows propagating upwards indicate the twist hackle departing from the edge chip at the region related to hexagon vertex. **(b)** SEM image of zone 2 showing twist hackle emanating from the abutment region that was in contact with the lower edge of the abutment screw head and a lateral arrest line (white arrowheads). **(c)** SEM image of zone 3 showing the compression curl at the occlusal wall (white arrowheads). **(d)** SEM image of zone 4 showing fractographic features (twist hackle, lateral arrest line and micro-fine hackle lines) like the homologous zone. **(d)** SEM image of zone 5 showing fractographic features (micro-fine hackle lines) like the homologous zone.

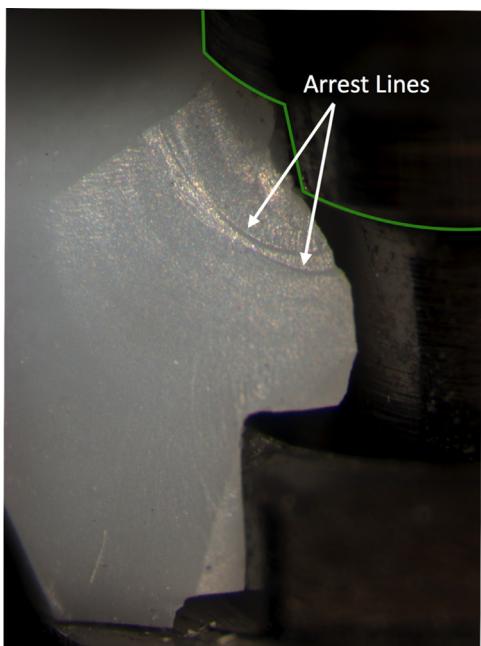
Fig. 6 shows two arrest lines visible on a broken part from the connecting region of another representative abutment providing evidence that damage started at this region. The failure origin is located on the concave side of the first arrest line, i.e., near the edge of the abutment screw head. A close-up image of Fig. 6 under the SEM confirmed the presence of these features including huckle lines (Fig. 7).

Fig. 6 – Stereomicroscopic image showing chip damage delimited by arrest lines (white arrows). The green line indicates the contour of the abutment screw head and highlights its proximity to the failure origin. (For interpretation of the references to color in this figure legend, the reader is referred to the web version of this article.)

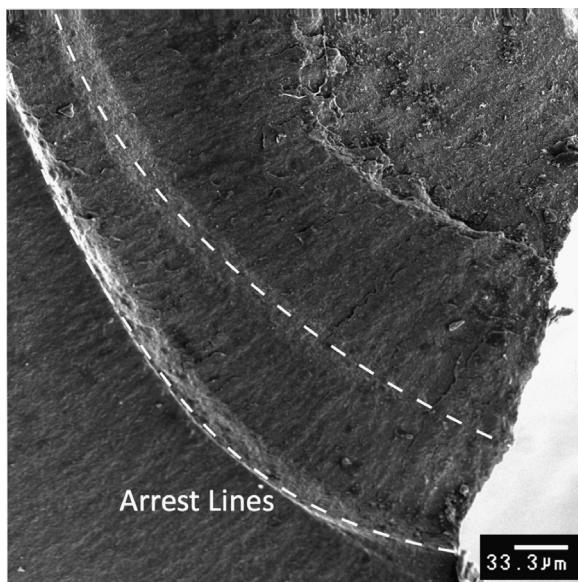
Fig. 7 – Higher magnification of Fig. 6, confirmed the presence of arrest lines (dashed white line) from which fine hakele lines emanated.

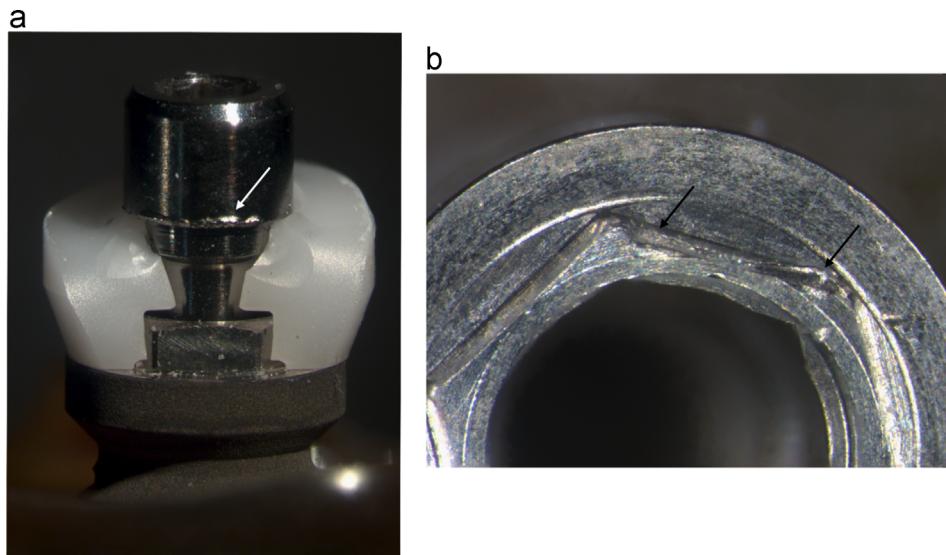
Fig. 8a and b shows stereomicroscopic images of the metallic components. Some samples exhibited scratch marks on the screw head and fracture/deformation of the implant platform as indicated by the arrows.

Fig. 8 – (a) Representative abutment screw damaged at the lower edge of the screw head (white arrow). **(b)** Representative implant damaged at the external hex platform (black arrows).
