Monitoring Bank Erosion in Hydroelectric Reservoirs With Mobile Laser Scanning

Index Terms—Environmental monitoring, erosion process, mobile laser scanning.

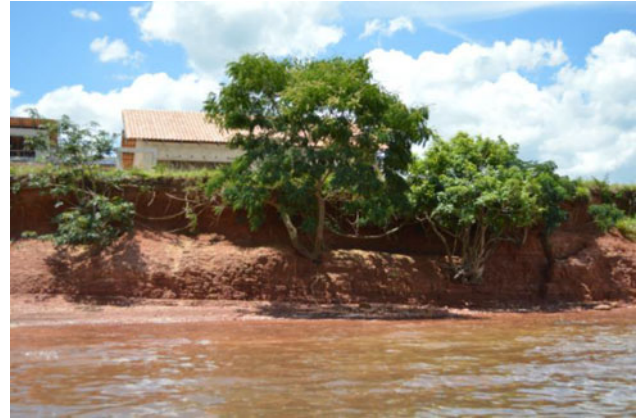
Fig. 1. Example of bank erosion at a hydroelectric reservoir on the Paranapanema River, Brazil.

BANK erosion is a natural process that occurs on the margins of water and is caused by waves, wind, and water infiltration. Human activities near or inside lakes and reservoirs can speed up the erosion processes, resulting in loss of productive areas, environmental damage(s), and lawsuits against the reservoir's managing company. Fig. 1 shows an example of a site subjected to the process of bank erosion.

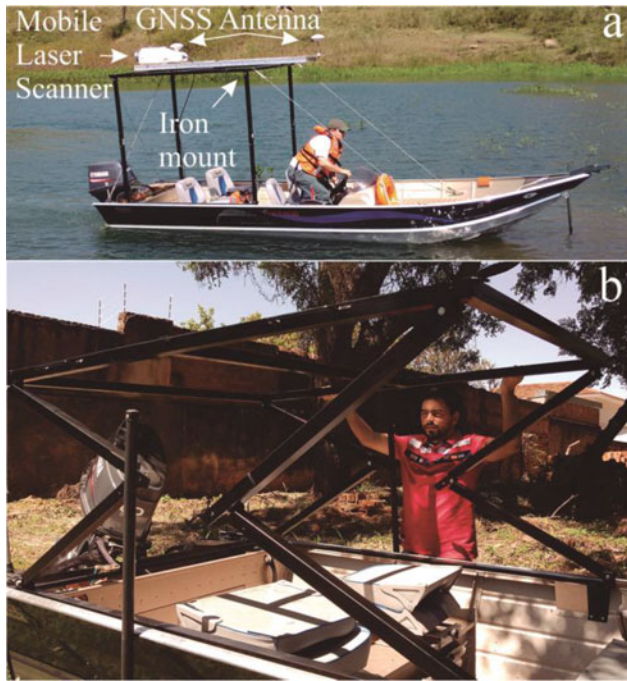
Fig. 2. (a) Motorboat equipped with laser scanning system and its components; (b) hinge system on the iron mount to facilitate the scanner and accessories installation.

A motorboat 5 m long was retrofitted with an iron mount that was specially designed to carry the Dynascan and its accessories. Fig. 2 shows the hinge device of the mount that was developed to facilitate the complete system installation. After the completion of the installation, the mount is raised to the survey position, which is 1.60 m above water level. Considering the mean height of the banks, 1.5 to 2 m, this mount height allows surveying data for eroded areas and the natural terrain depending on the scanner-to-river-bank distance. Fig. 2 shows the metallic mount on the boat with the system components, which have known positions on the metallic mount. The base length between the two GNSS receivers was accurately measured by surveying techniques.

A Nikon D5000 RGB camera equipped with a single-frequency GPS navigation receiver was jointly installed with the Dynascan at the iron mount to acquire images from the bank during the scanning sessions. These images were acquired by manual triggering and were used to support the filtering step described in Section IV.

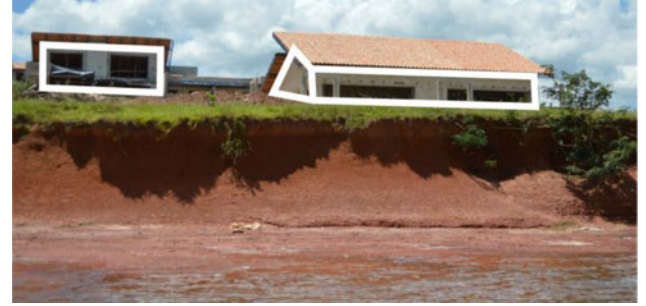
Fig. 4. Building façades facing the reservoir used as control features.

One of these erosion processes affects an urbanized area neighboring the reservoir. Fig. 4 shows some buildings with well-defined façades facing the reservoir. Due to the difficulties of installing targets at the margin of the reservoir, three façades were surveyed with topographic methods and used as control features to assess the mobile-laser scanning accuracy.

The façades were surveyed by single radial measurement (one angle and one distance) and the station coordinates were determined by GNSS positioning. Based on the surveyed points, the plane parameters defining the façades were estimated using the least squares method implemented in a MATLAB algorithm called “Fit-Plane.” These planes were used as control surfaces to assess the quality of the laser scanning data.

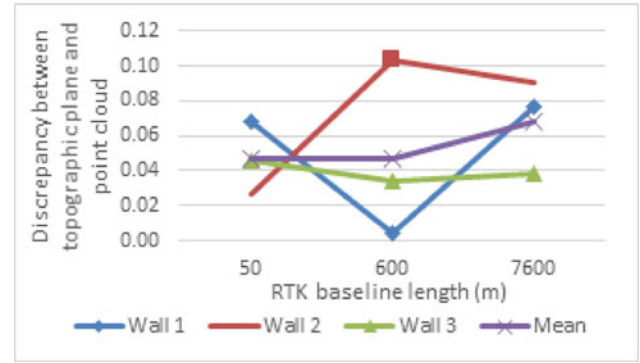
Fig. 6. Average discrepancies between the point cloud and the surveyed planes according to the RTK baseline length.

The average distances between the reference planes and laser scanning data in this experiment are closer to the nominal system accuracy of 5 cm, except for wall 2 with the RTK at 600 m, which gave average distances of 10 cm. For baselines shorter than 1000 m, the accuracy achieved is comparable to the nominal accuracy. However, by comparing the accuracies achieved with base 1 and base 3, it is possible to see an increase on discrepancies of approximately 40%, when there is an increase in the distance between the reference base and the laser scanner.

It can be concluded that the RTK baseline length influences laser scanning accuracy, but it was unfeasible to model this accuracy degradation analytically based on the acquired data. Further experiments using more base distances and controlled data would be required to establish a model for the prediction of accuracy for this equipment.
