## Isothermal Fatigue Characterization of P91 Steel Under Load Control

P91 steels are widely used in power plants. They were developed in a context of increasing process temperatures to increase efficiency and reduce CO<sub>2</sub> emissions into the atmosphere. In this sense, the energy industry aims to increase its efficiency and process control, for which temperature control is essential and welding thermocouples in P91 steel pipes may be necessary. In this context, this study aims to evaluate, in a preliminary way, the influence of welding thermocouples in P91 steel specimens subjected to fatigue testing. The results showed that in general there is a decrease in fatigue life, more prominent for 90 and 80% of the load. In addition, the insertion of defects such as welding points increases the probability of the initiation of fatigue cracks in the welded areas due to loss of properties. From 70% of the load onwards, infinite fatigue life was achieved for the welded and as supplied cases, and in both conditions the same fracture shape was obtained, observed macroscopically.

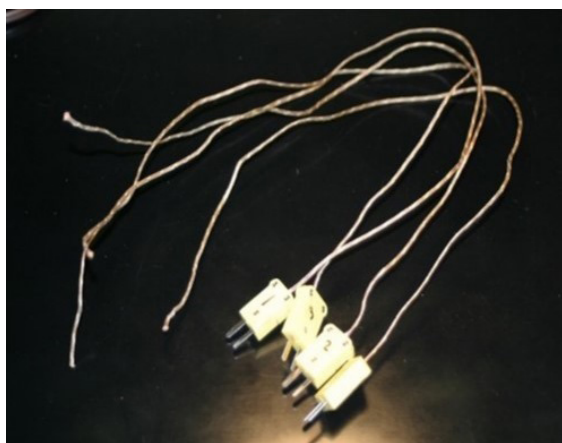
The thermocouples used in this study were the Lead Wire Type K 24 Ga., with insulation of fiberglass and being able to stand temperatures up to 900°F (482°C). Type K TCs are shown in Figure 2.

Figure 2. Type K ribbon TCs.

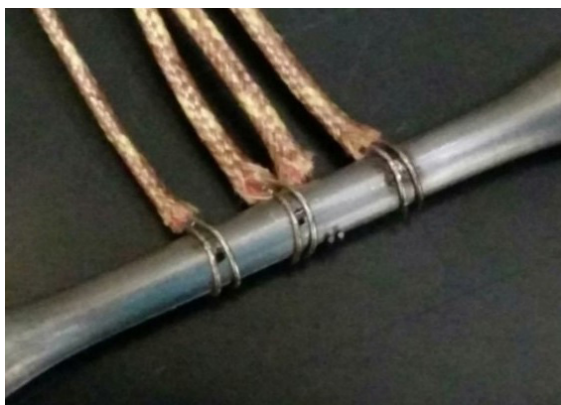
They are ribbon type TCs and have to be welded with the wires perpendicular to the specimen's axial direction, and parallel with respect to each other, with an ideal distance separation of 1 mm between each wire, as shown in the Figure 3.

Figure 3. Welded TCs.

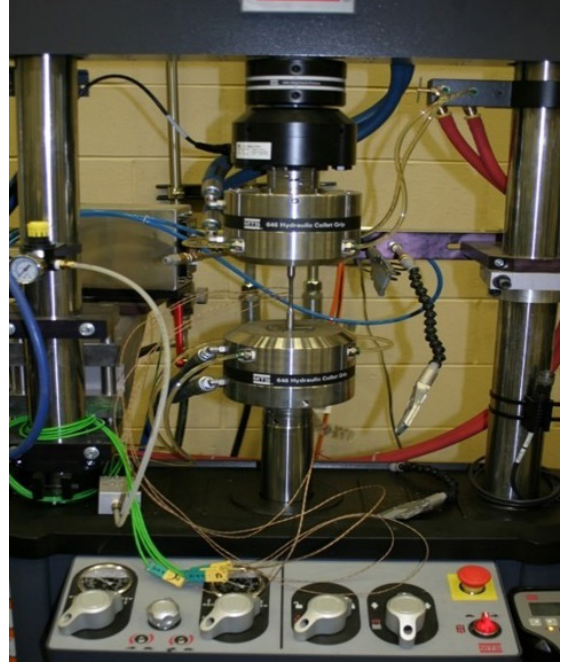
The testing machine used in this study is shown in the Figure 5. It allows performing fatigue tests under load control and has an actuation force capacity up to 100kN. The Figure 5 shows the testing machine.

Figure 5. Testing machine.
