GEOSCIENCES

Integration of multisources data for quarry slope stability assessment in the Itaoca district (Southeastern Brazil)

MARCOS EDUARDO HARTWIG & CÉSAR AUGUSTO MOREIRA

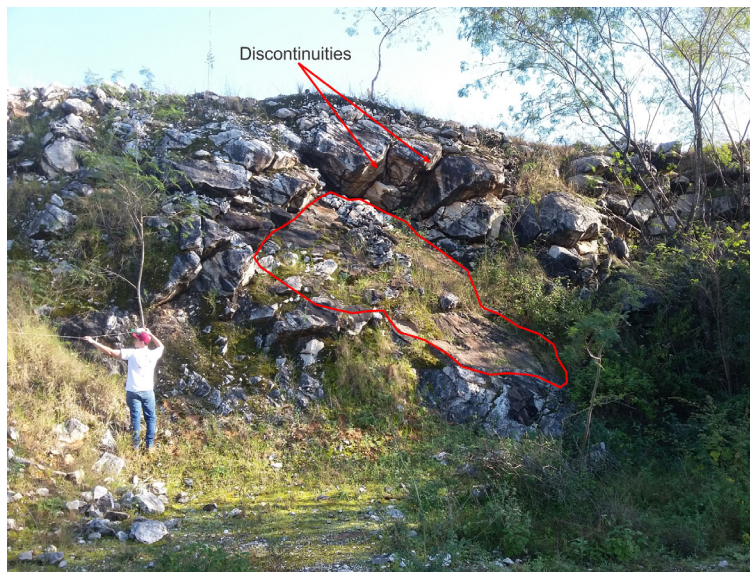
Figure 5. Planar failure affecting NW Slope. Slip occurs due to the presence of a dike of metamafic rock 15 cm thick. Note the existence of release joint planes in the upper portion of the slope.

planar failures, it is also necessary to consider their persistence through the slope and the presence of lateral releasing planes. Therefore, it is concluded that this failure mechanism does not interfere quarry slope stability. Nevertheless, a planar failure was observed on the NW Slope, conditioned by a dike of metamafic rock, and another one occur at Bench 2 of the NE Slope (Figure 5).

- Wedge and planar failure modes are the most critical in the study area, and essentially affect the first two benches of the NE Slope. The mafic rock dikes can also trigger planar sliding as observed in the NW Slope;
