ICM11

Fatigue Strength of X45CrSi93 stainless steel applied as internal combustion engine valves

H. J. C. Voorwald^{a*}, R. C. Coisse, M. O. H. Cioffi

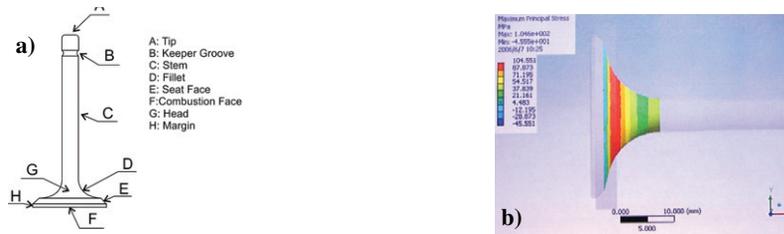
Fig. 1. a) Nomenclature of Engine Valves [3]. b) Stresses applied on an intake valve fillet area [4]

Valves are components responsible for the opening of internal combustion engine cylinder in order to the moisture fuel-air to income during the intake stroke and for the exhaust of the burned combustion gases at the exhaust stroke as per showed in Figure 1a.

The Figure 1b shows some typical combined stress distribution on an Otto intake valve fillet.

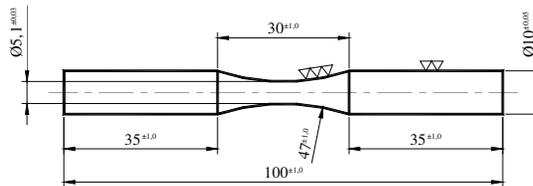
Figure 2 – Fatigue Specimen with dimensions in mm [5].

The X45CrSi93 Specimens have been prepared from hot rolled bars machined, quenched and tempered according to the following specifications: 30 minutes of austenitizing at 1040°C in an Ipsen T-6 furnace with 0.40% of carbon potential atmosphere and quenched in medium cooling rate oil; 60 minutes at 680°C in a continuous LWBU furnace and calm air cooled to reach 35 HRC/45 HRC, wich garatee the endurance and wear resistance, maintaining the ductility required to the impact resistance [3]. Specimen in Fig. 2 was performed according to ASTM E466 with constant radius between parallel sides [5].

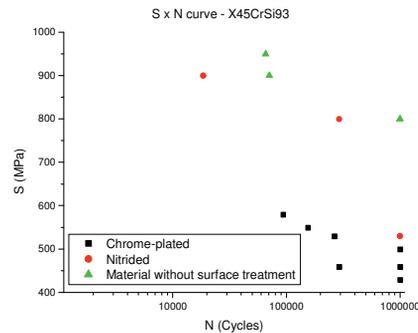
Figure 3 – Axial fatigue curve

Axial fatigue SxN curves are represented in Fig. 3. The fatigue limit is directly proportional to the mechanical strength [7] regarding to chemical composition, heat and thermochemical treatments. As hardness increases due to the chemical composition changes in the steel nitrided layer superficial mechanical resistance is higher, which is directly reflected by fatigue strength. To Shen et al. [8], this phenomenon is the consequence of increase in solid solution.

Results of fatigue tests show an increase of about 50% in strength of nitrided specimens compared to the electroplated ones, associated to increase in mechanical strength regarding solid solution surface provided by the interstitial diffusion of nitrogen.

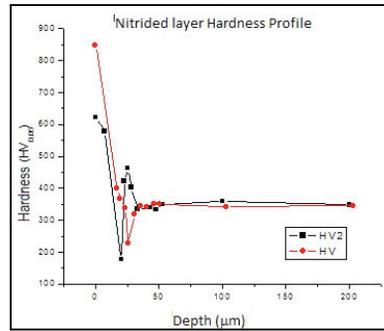
Figure 5 – Micro-hardness profile of the nitrided layer

For analysis of the nitrided region the hardness profiles, in order to determine the actual nitrogen diffusion depth, were initially raised. Results are shown in Figure 5.

Note that the surface hardness is between 622 and 848 HV_{0.05}, followed by a significant drop down to a minimum hardness associated to the matrix. The metallographic analysis of the nitrided layer has a surface layer of oxides, followed by a region of recrystallized grains and apparent decarburization.

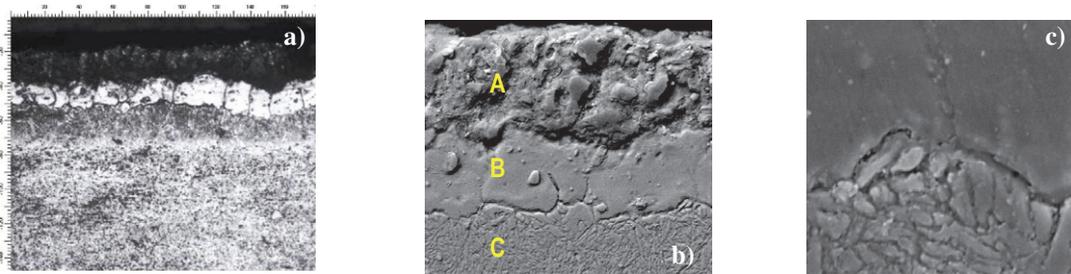
Figure 6 – a) Typical found Nitride layer microstructure, 400x, Nital 10%. (21BTN), b) Nitride layer microstructure formed below

the decarburized grains, 2,000x, Nital 10%. (21BTN), c) Microstructure of the interface between decarburization and diffusion layer 10,000x, Nital 10%. (21BTN)

Immediately below these grains, at the diffusion layer, it is possible to find some nitride precipitation at grain boundaries. The matrix microstructure is evidenced by approximately 60 μm from the surface. The compound layer, also known as white layer was not observed, due to loss of surface alloy verified by decarburization, which also caused the low hardness values even below the values found in the matrix core. In figures 6 a, b and c layers are shown.

The oxide layer, shown in figure 6 b as a region "A" has a large amount of silicon (8.6%), chromium (1.9%) and oxygen (3.4%), with relatively low iron content (86.1%), compared with other regions of the formed nitrided layer. In region B, the oxygen gives place to nitrogen, which shows concentration of 1.7% and silicon and chromium exhibit concentrations of 2.2% and 2.9% respectively and the iron content is 93.2%. Finally in region "C", regarded of diffusion layer, silicon and chromium concentrations present closer to the array, with 2.4% and 6.9% respectively. The iron, similarly presents concentrations closer to original composition of the alloy. The significant loss of alloying elements on layer "B" characterizes the decarburized region.

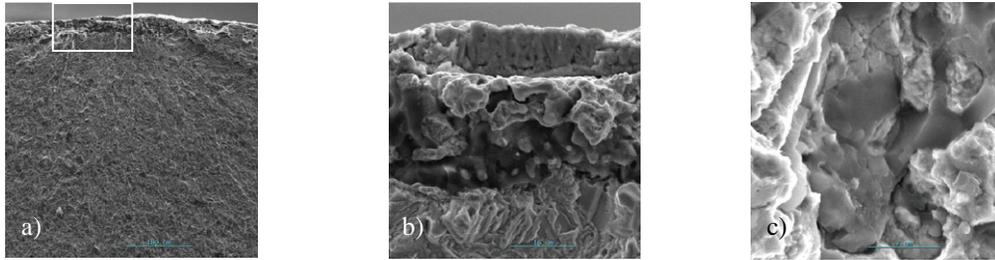
Figure 7 – a) Nucleation site and start of fatigue propagation; b) Detail of the fatigue crack nucleation site; c) Fracture surface in the decarburized region.

The figures 7a, b and c show darker regions, characterized by the lower amount of alloy elements with higher chemical weight [12]. The evidenced cracks were nucleated at the specimen surface, figure 7a; however, it was observed propagation in two entirely different ways. Even within the nitrided layer, it is possible to find more brittle fracture propagation. From the end of the intermediate diffusion layer a transgranular fatigue propagation is observed, in which the amount of nitrogen decreases significantly.

The fatigue crack propagation occurred through the oxide. In the decarburized layer, the fracture propagated primarily in two ways, with ductile and rough appearance in regions with higher concentration of alloying elements and brittle and smooth where these concentrations are lower and consequently the nitrogen contents are higher.

At the diffusion layer and at the specimen core the fracture propagation was typical transgranular up to the final rupture. It is possible, in figure 7b, to see the different fracture propagation between the regions with higher and lower nitrogen contents. The fatigue crack propagation below the surface layers is typically transgranular through the martensite laths is indicated in Figure 7c.

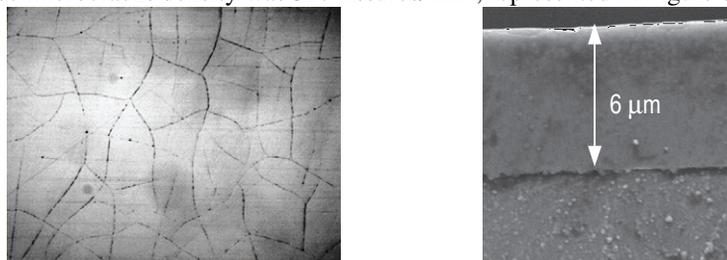
Figure 8 – a) Microcracks density at the surface. 200x not Etched; c) Chrome-plate metallographic, 10.000x, Nital 10%.

The chrome-plated presented along the surface an average hardness of 1050 HK measured from a load of 25g. The plate surface microcracks density was 327 fissures/mm², represented in Figure 8.

In the figure 8a it is also possible to see two layers of fissures on the studied plate. This fact occurs during the chrome-plate formation and can be considered as a cyclical phenomenon. After the deposition of certain chrome thickness, enough to raise the plate stress above the chromium resistance, the first cracks forms in order to relieve the stress. As the plating process continues the stress starts to grow again and new cracks are formed over the last one [8]. It was not evidenced so significant level of dealloying on the plated samples as found on the nitrided ones associated to the plated specimens needed to be polished and alkaline pickled as preparation for plating process. It was observed 6 μm chrome-plate as indicated in Figures 8b.

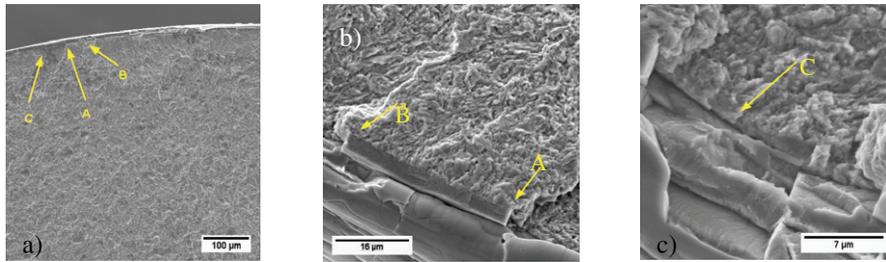
Figure 9 – a) Fracture initiation – 200x; b) Nucleation points “A” and “B” – 2.000x; c) Nucleation point “C” – 2.000x

The fatigue fracture was nucleated at the specimen surface coincident to the chrome-plate cracks. The fracture at the chromium layer was brittle with signs of delamination (figures 9a), the propagation occurred through the chromium layer in different plans. These delaminations can be seen on the nucleation sites “A” and “B” in Figures 9 b and c.
